Sento LED heads lens hooks

In **first-generation Sento LED luminaire heads sold before July 2015** it is possible that the lens hooks can become distorted with intensive operation due to a problem with the metal alloy. **In very rare instances, this can lead to the lens being released from the hook.**

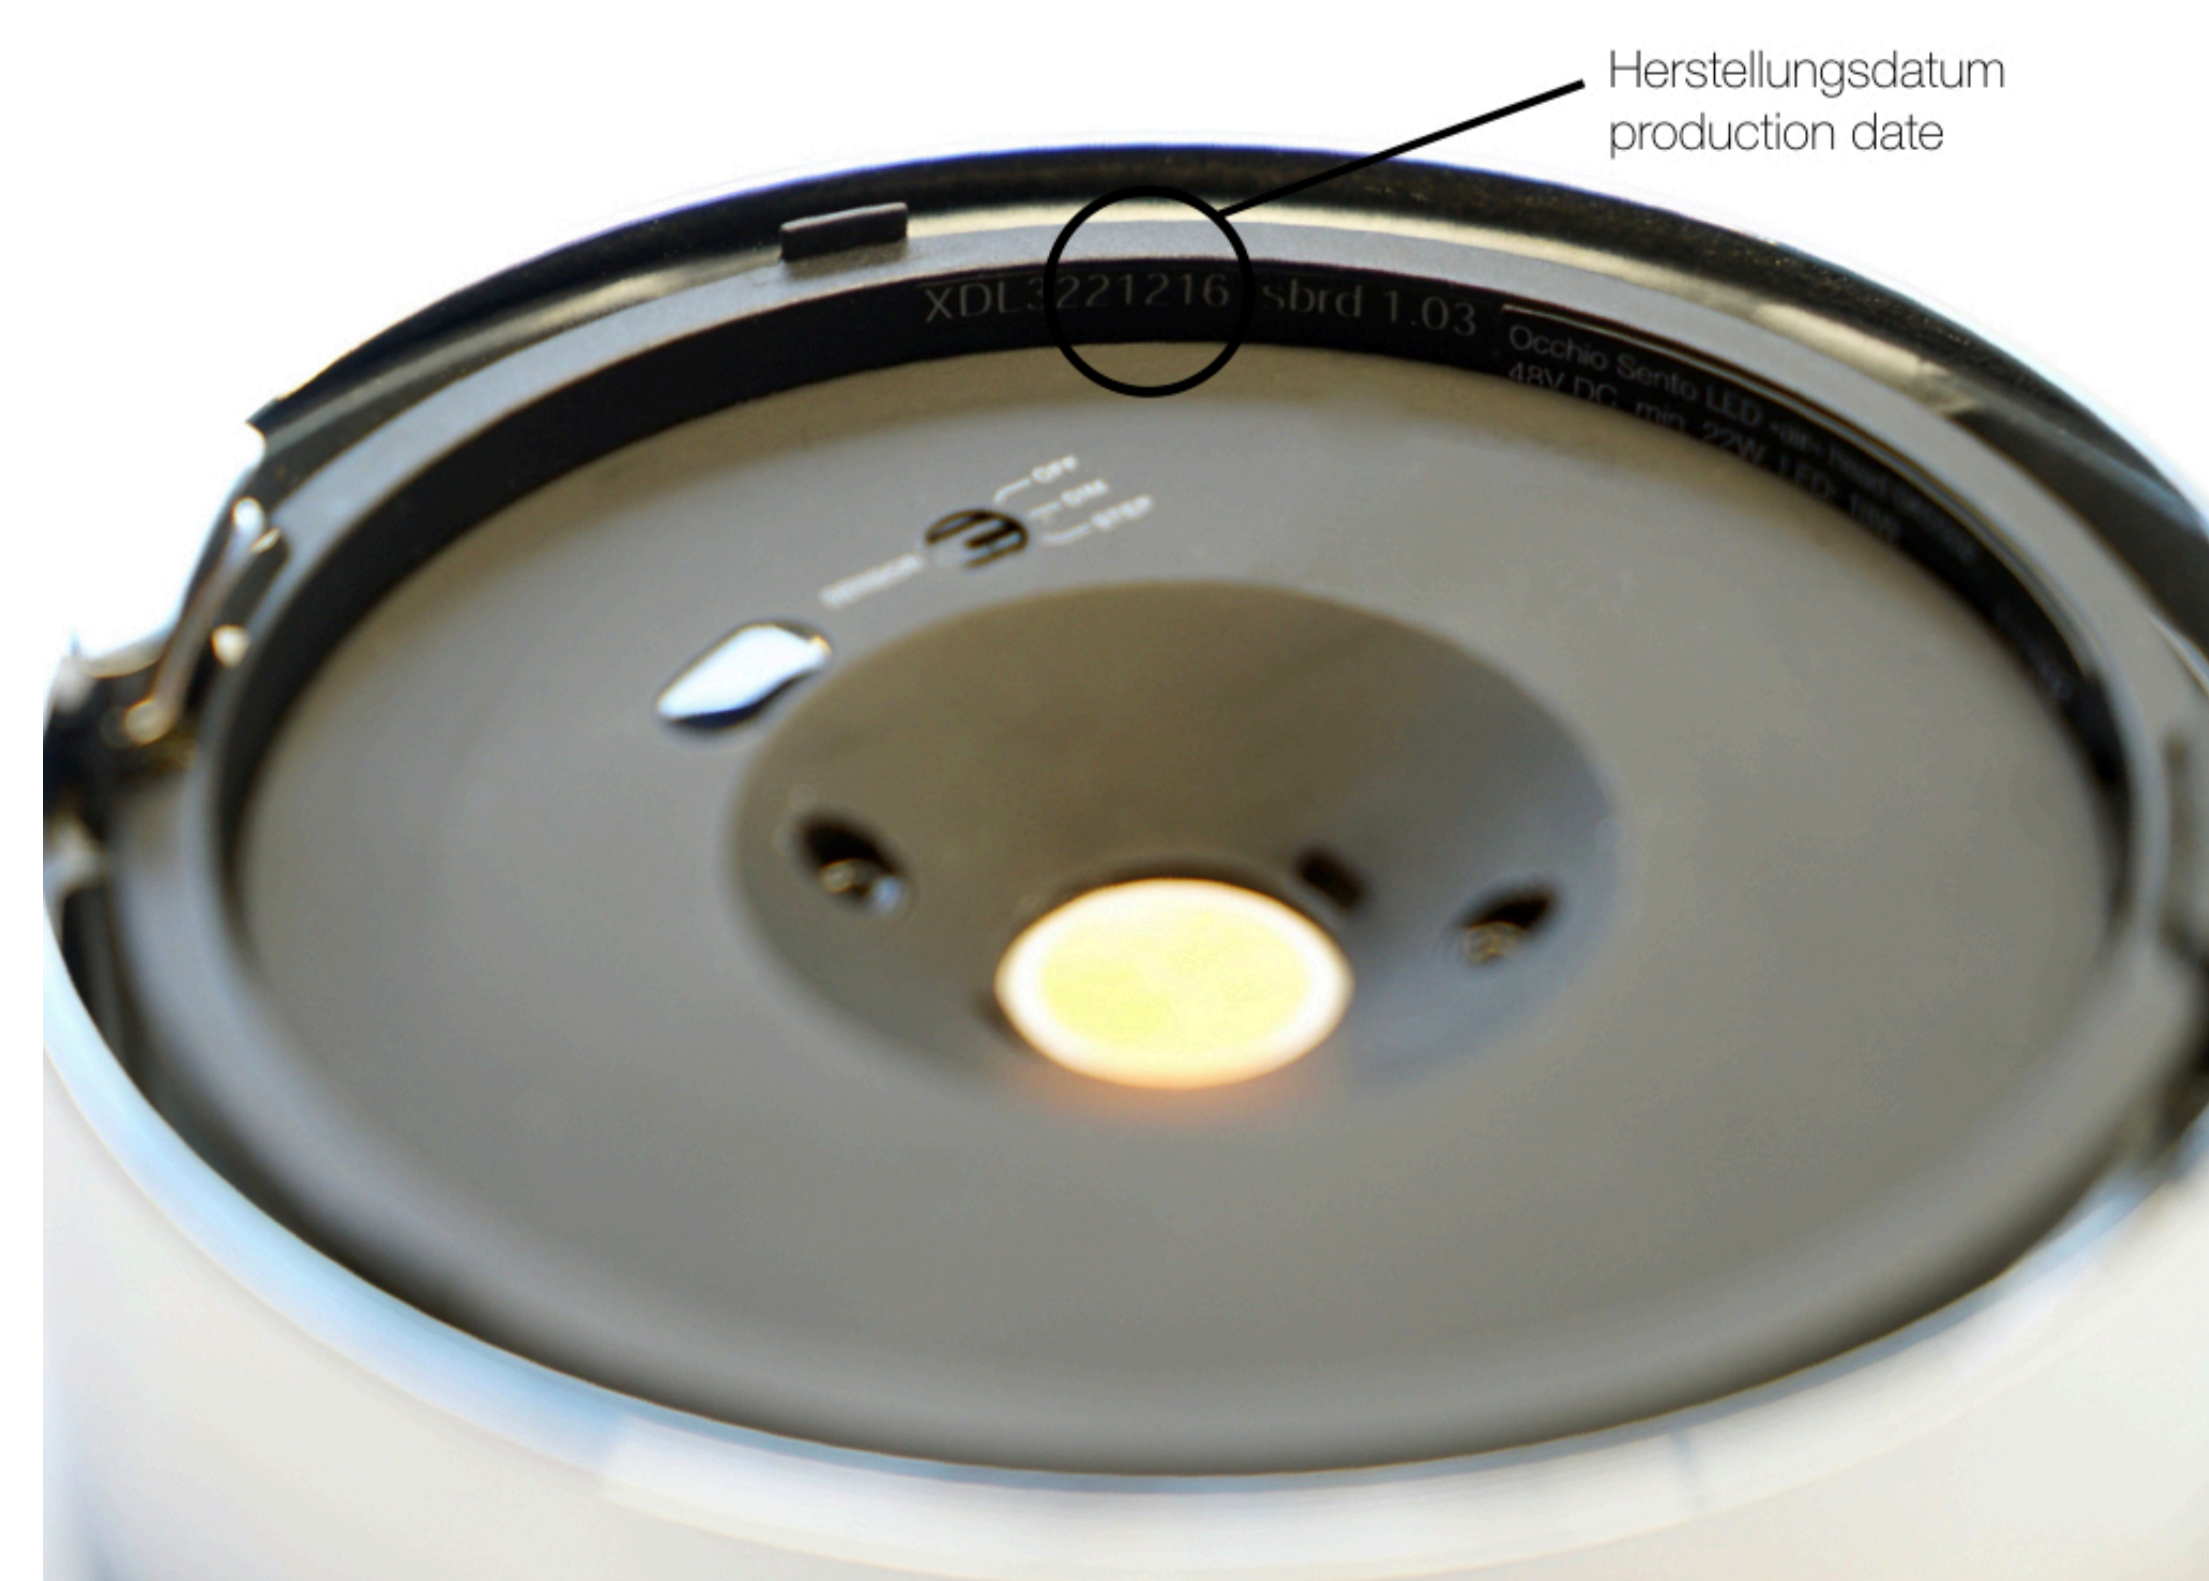
How to identify the date of manufacture:

If you are not sure how old your luminaire heads are, you may find the date of manufacture at the point marked in the picture. Simply remove the lens and look at the inside of the socket.
